Skhalta Community Briefing Report

Engineering Geological and Geotechnical
Assessments for Landslides

August 2013

Adjaristsqali Georgia LLC

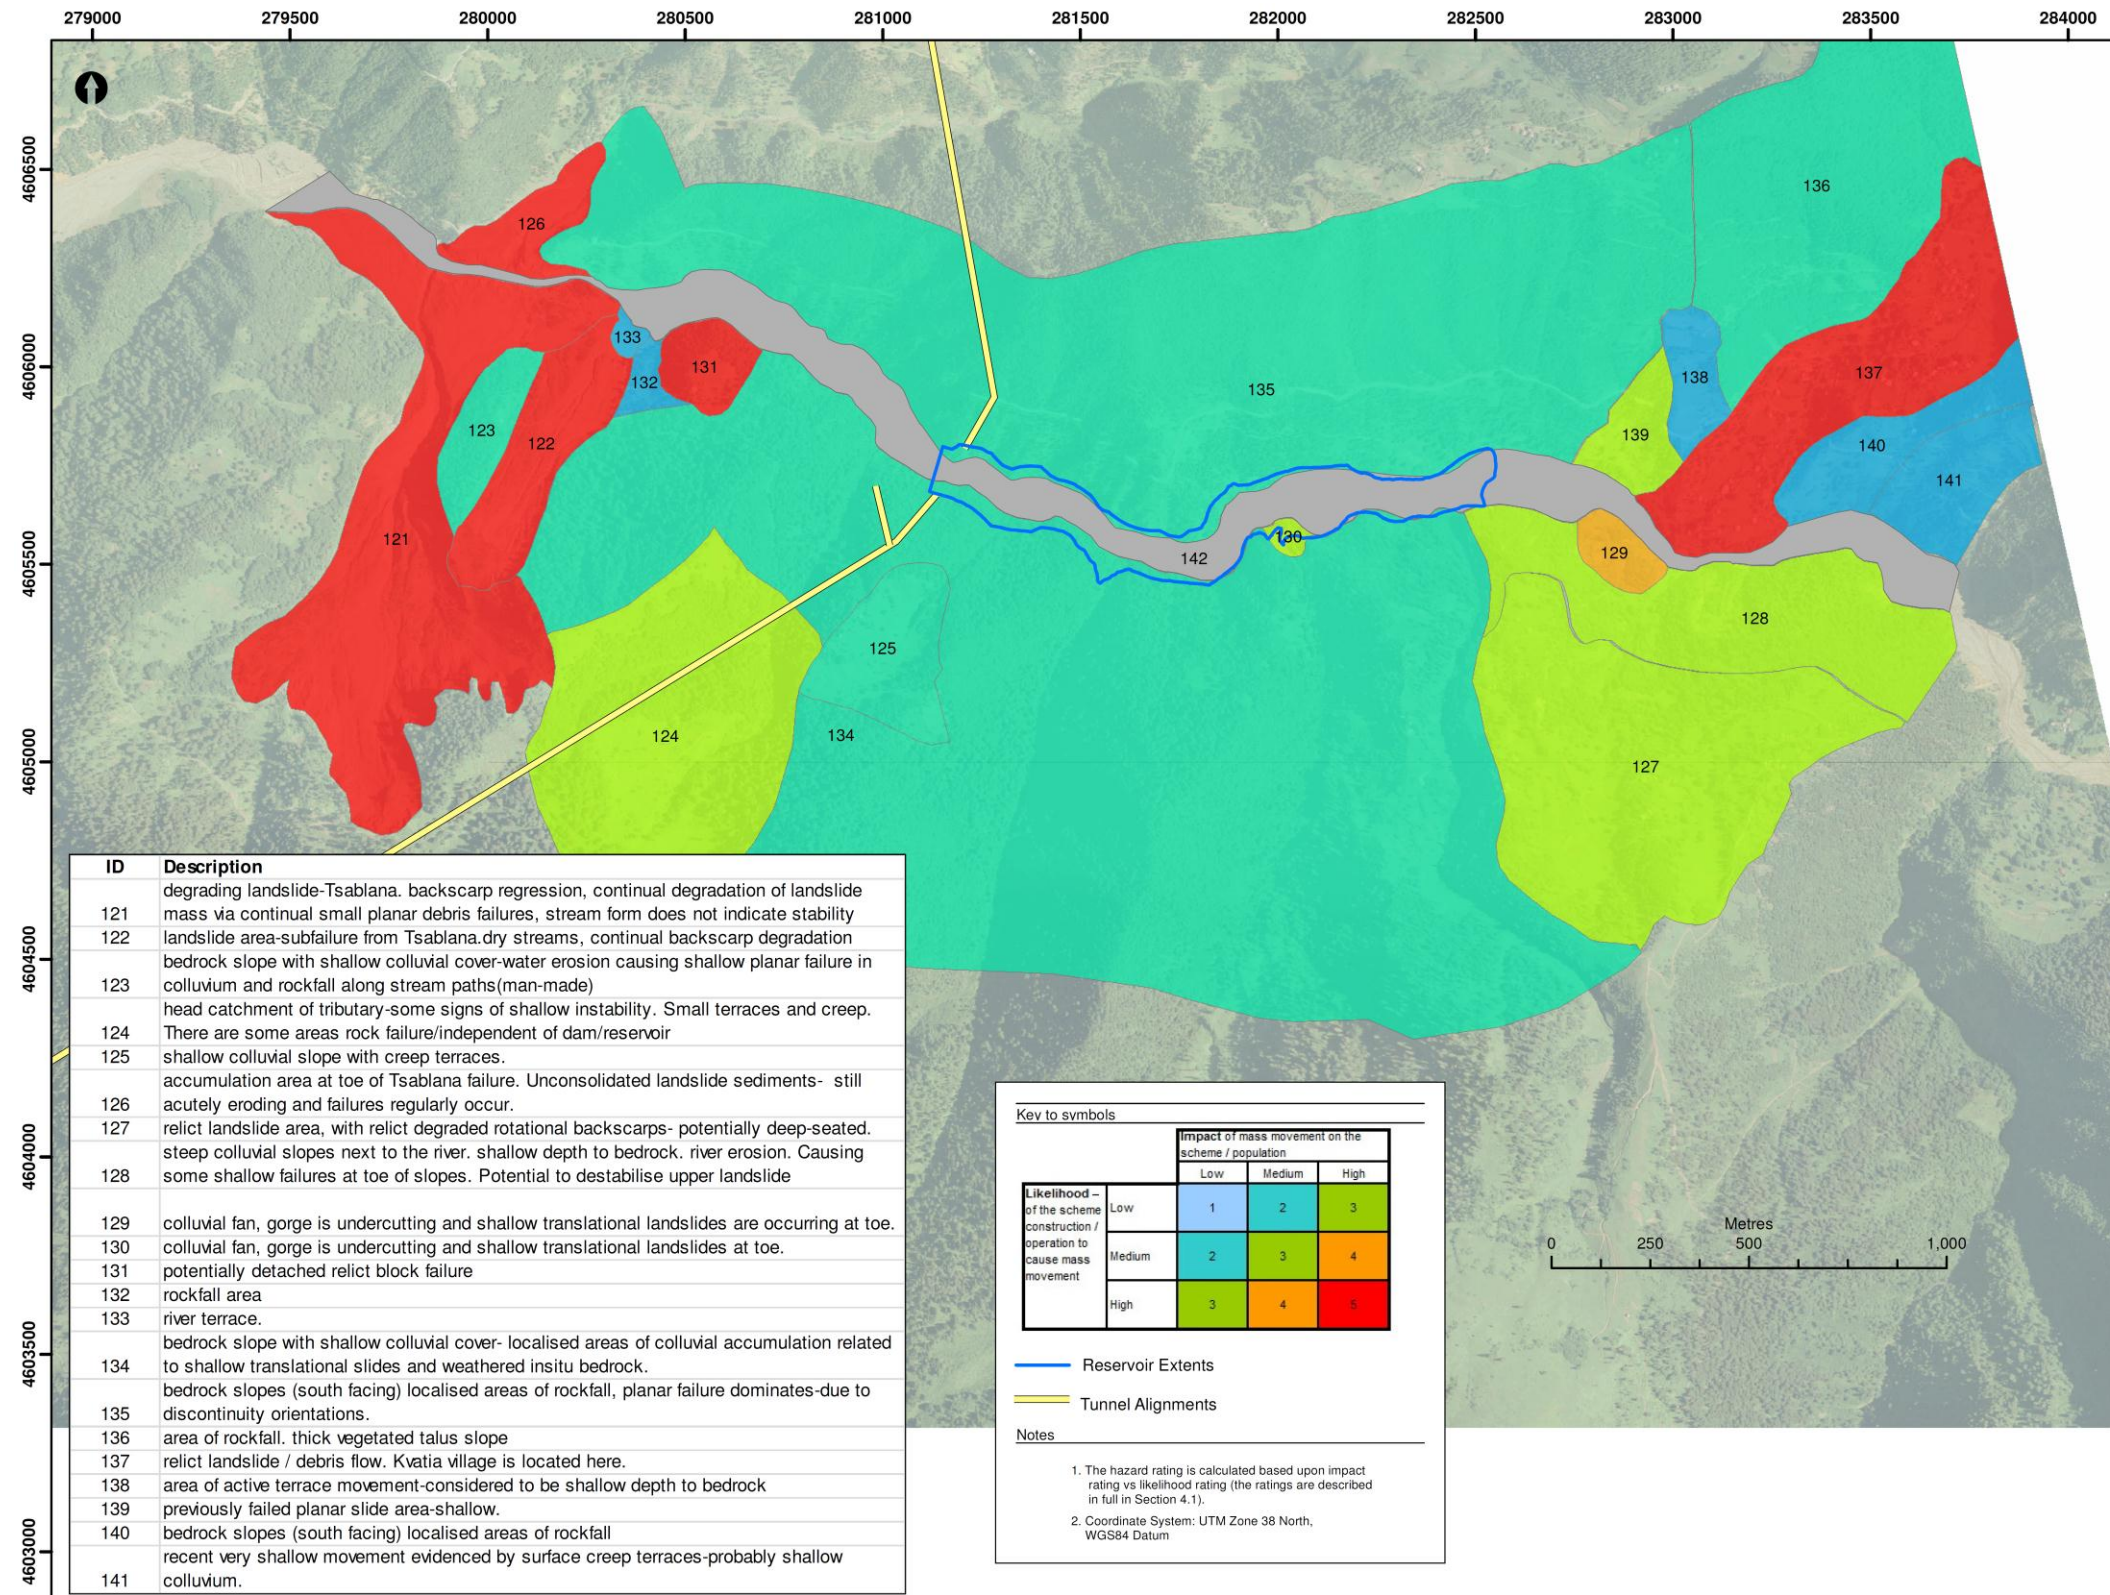
Figure 4.3: Landslide Hazard Map for Skhalta

Following the completion of the geomorphological studies, all of the available information was considered together to carry out a landslide hazard assessment for the Skhalta area and the results presented on a landslide hazard map, Figure 4.3. It must be emphasised here that the landslide hazard map does not only indicate hazards that may result, in part, due to the effects of the proposed reservoir. The fieldwork also considered the hazards that are actively occurring, with no direct influence from the proposed reservoir. However, the risk rating assigned is based on the likelihood of the scheme construction causing a landslide.

The assessment indicated that all identified local dwellings, farmland and infrastructure were located on landslide units identified as numbers 125, 127 and 137, Figure 4.3.

- Major and Critical features - Avoid (i.e. move structures and reservoirs or limit their extents if required)
- Moderate features – Subject to further assessment and potentially engineered solutions
- Negligible and Minor features – No action

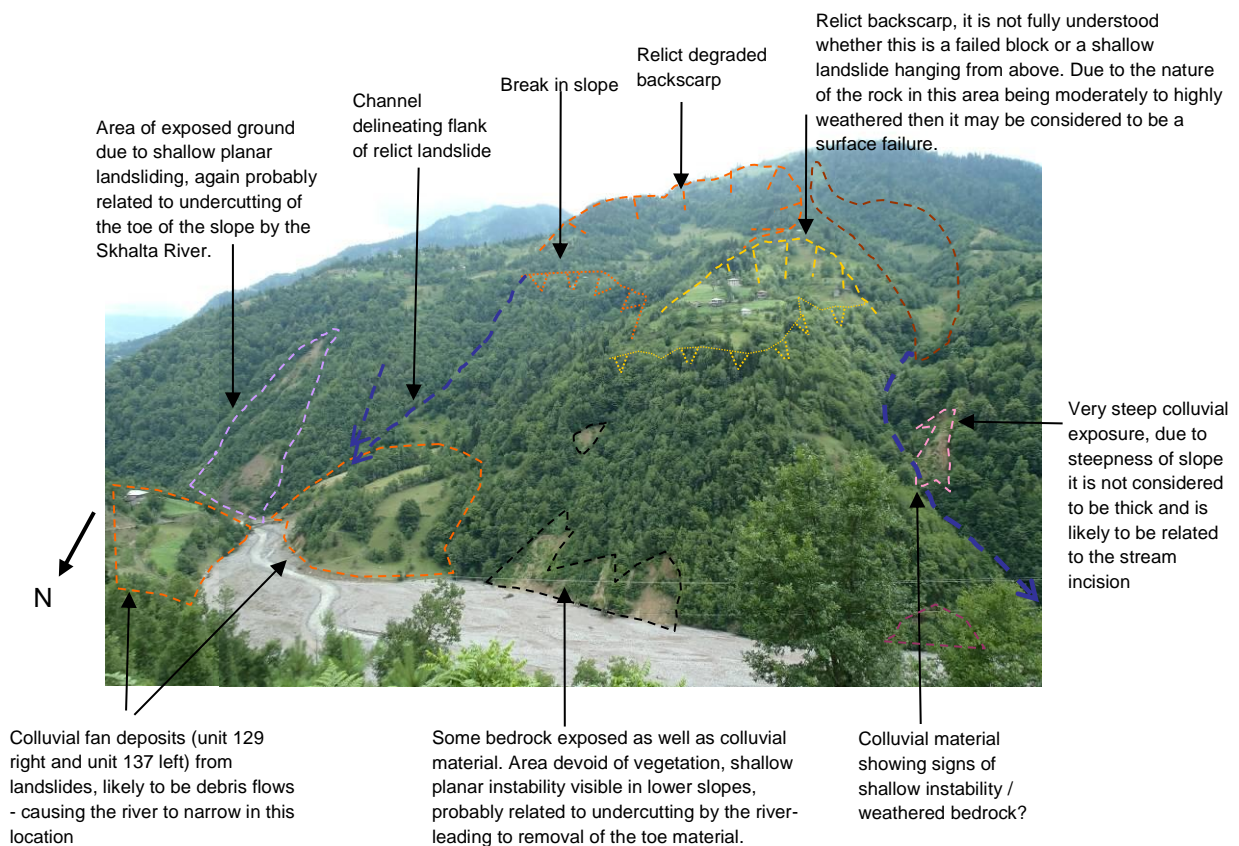
The geomorphology of unit 127 indicates that the residential properties present are located on a relict landslide, the base of which daylights approximately 70m above the current river level. At the identified base of the landslide there is a break in slope where slopes increase from the gentle 5-10° above to steep 50° slopes descending to river level Figure 4.4 . The steep 50° slopes are classified as unit 128 in Figure 4.3. Mapping observations on the 50° slopes noted rock exposures showing through a colluvial drape, in certain locations where undercut by the current river. These observations indicate that the current valley side is rock below a limited cover of colluvium and that it is unlikely to be connected to the slopes of the relict landslide, unit 127, above. It is considered that the river has cut down since the formation of landslide unit 127 leaving a rock outcrop at the river level that has been covered by a limited build-up of colluvium; resulting from weathering and accumulation of erosion products and rock fall from above. Based on these observations there is no mechanism for the proposed reservoir to result in reactivation and further movement of unit 127. The exception to the conditions noted above was at the location of landslide unit 129 (Figure 4.3) where a much greater thickness of colluvial material is present at the base of the slope. At this location, there is more uncertainty in understanding whether the slopes at river level are connected with the slopes of landslide unit 127 above. Due to this uncertainty the decision was taken to limit the reservoir extent to a location downstream of landslide unit 129 thereby eliminating the risk.

Figure 4.4: View of the left bank of the Skhalta river – Corresponding to landslide hazard unit 127 in Figure 4.3

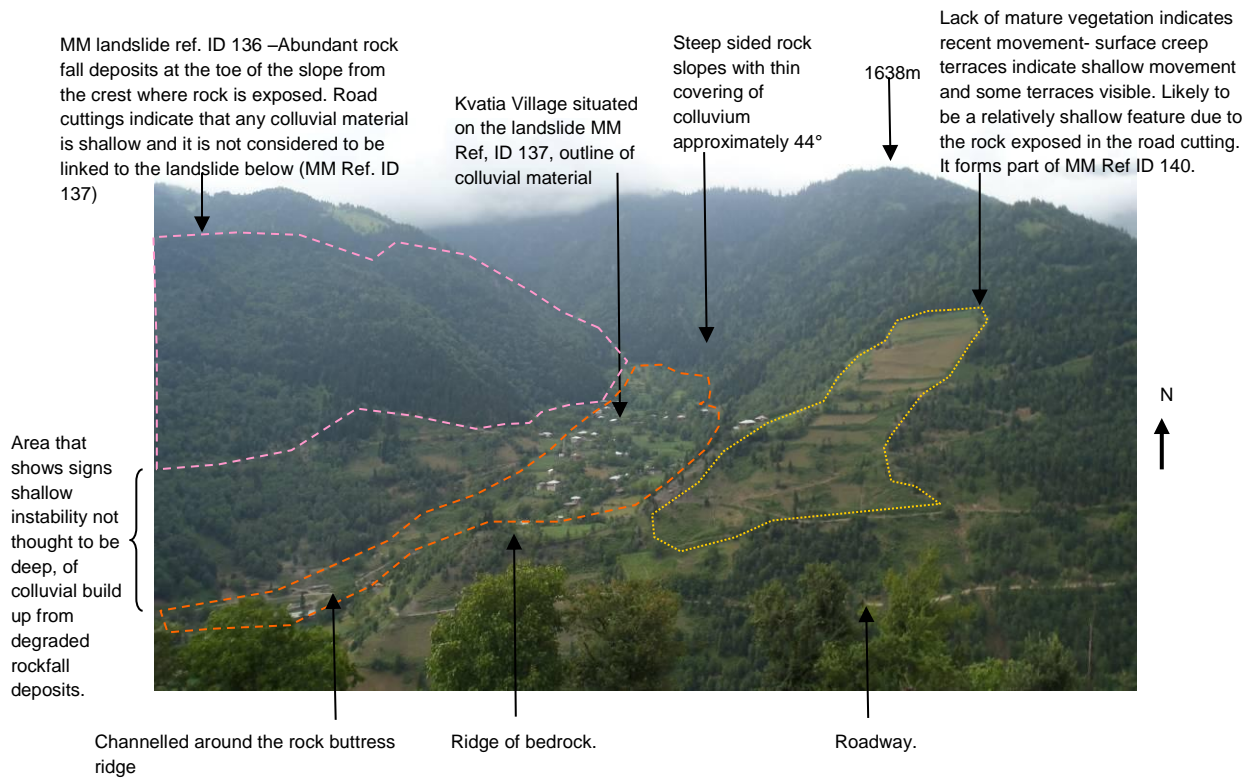
The village of Kvatia is located on a relict debris flow identified as landslide unit 137 in Figure 4.3. The observations indicate that the debris flow has considerable thickness (in excess of 10m) and extends all the way down to river level (Figure 4.5) where the toe is currently being eroded by the river resulting in small scale slumps of material. To the west of unit 137, unit 139 also extends down to river level where similar small scale slumps of colluvial material are on-going. Unit 139 is considered to have thin colluvial cover over rock based on exposures observed in road cuttings. Due to the structure and composition of these landslide materials, it is unlikely that they would remain stable if subjected to large increases in groundwater levels or fluctuations in water level associated with an operational reservoir. However, due to the location of the landslide at the upper end of the reservoir, during the assessment it was considered that the lower parts of these slopes could be protected to allow the shallow end of the reservoir (1-2m water depth) to extend to the slope bases without causing further instability. The considerations for landslide unit 127 noted above, however, resulted in the reservoir extent being limited such that it will not impact these slopes.

Figure 4.5: View of the right bank of the Skhalta river – Corresponding to landslide hazard unit 137 in Figure 4.3

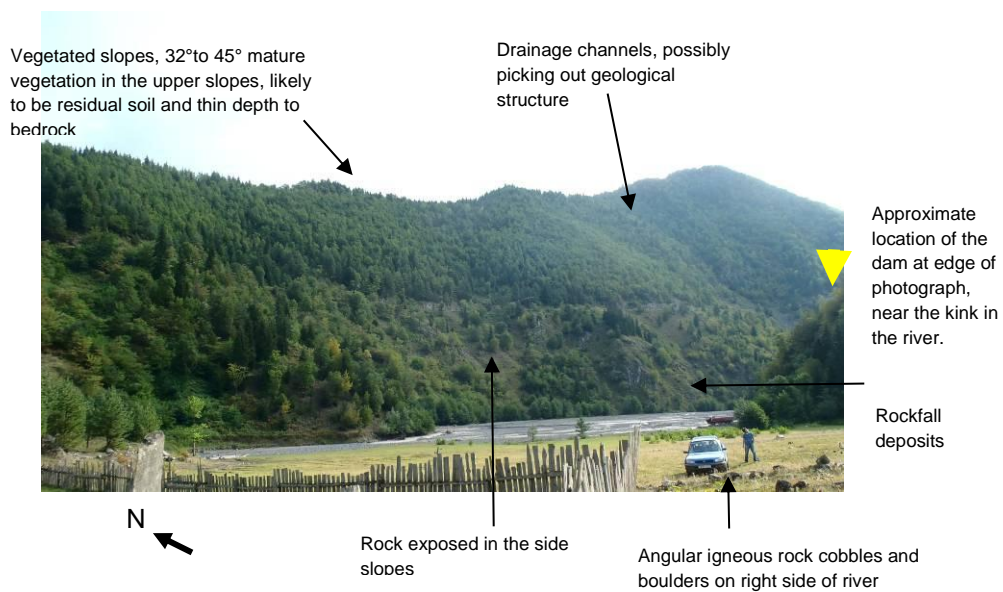
Unit 135 is located on the right bank of the Skhalta River. In this area the 30° to 45° slopes are vegetated and show regularly spaced, angular spurs that define drainage trends and likely follow geological structure. This morphology indicates generally stable rock slopes where erosive processes are dominating; forming drainage trends and depositing a build-up of erosive deposits at the slope bases. At a height of 100 to 120m above the valley bottom, rock is exposed along the valley in a road cut that leads to Kvatia village. The presence of rock is also noted sporadically below the road level and at river level where vegetation is thin and/or patchy. Between the proposed dam site and the kink in the river (noted just downstream of unit 130 in Figure 4.3) observations indicate that the slopes have a thin talus mantle that has accumulated from

Figure 4.6: View of the right bank of the Skhalta river – Corresponding to unit 135, downstream of kink, in river in Figure 4.3

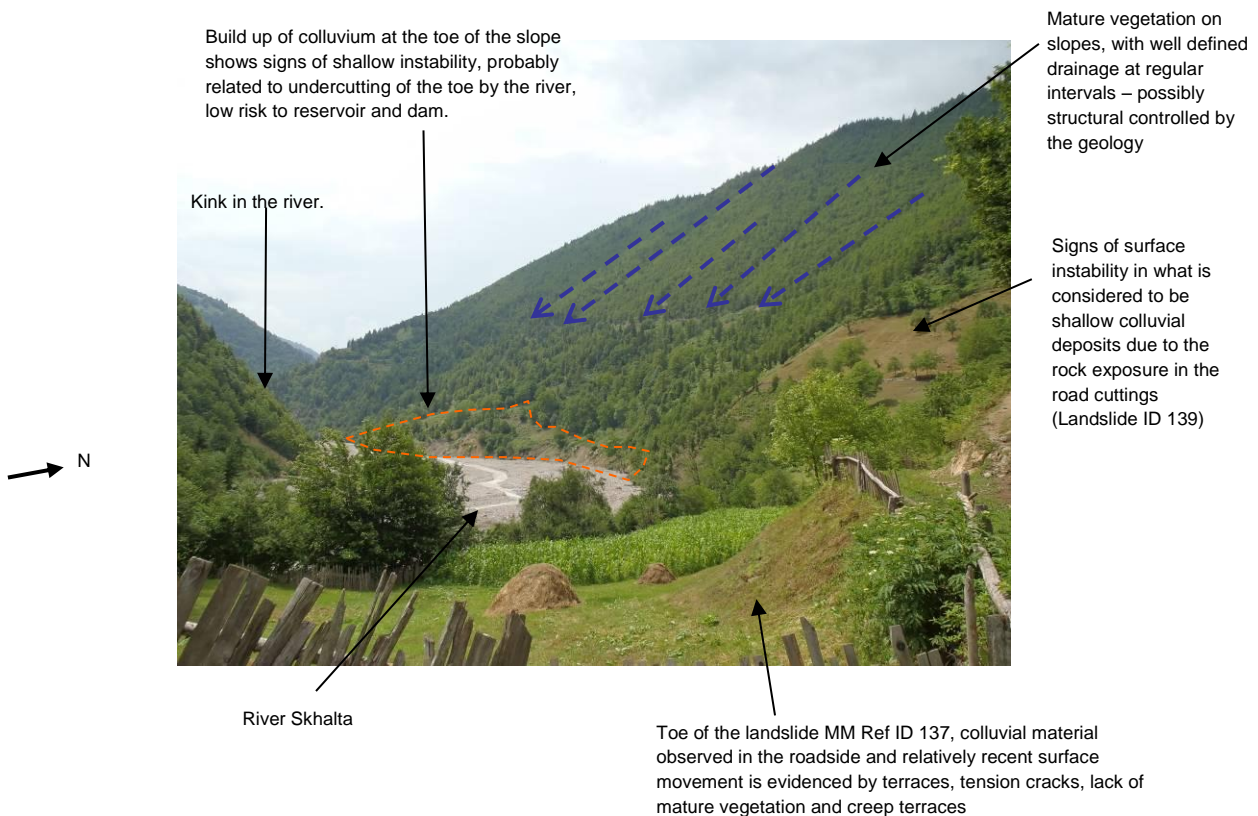
rock fall and is being eroded by the river (Figure 4.6). Upstream of the kink in the river observations indicate thicker deposits of talus and colluvium at the toe of the slope (Figure 4.7). These talus and colluvial accumulations show signs of shallow instability resulting from undercutting by the river.

Figure 4.7: View of the right bank of the Skhalta river – Corresponding to unit 135, upstream of kink in river, in Figure 4.3
