# Non-Technical Summary of Tunnel Collapse at Shuakhevi HPP

## Background

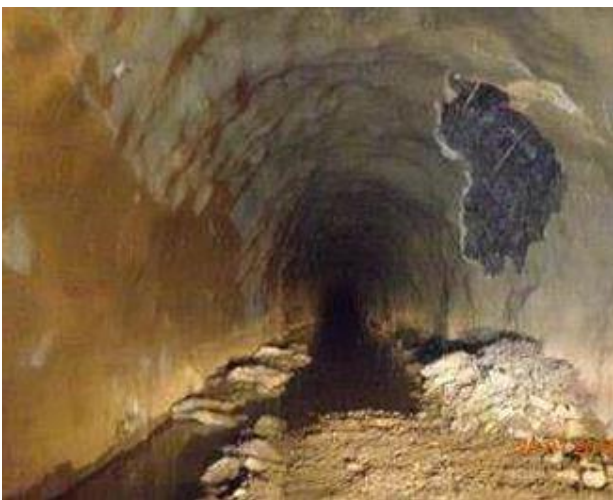
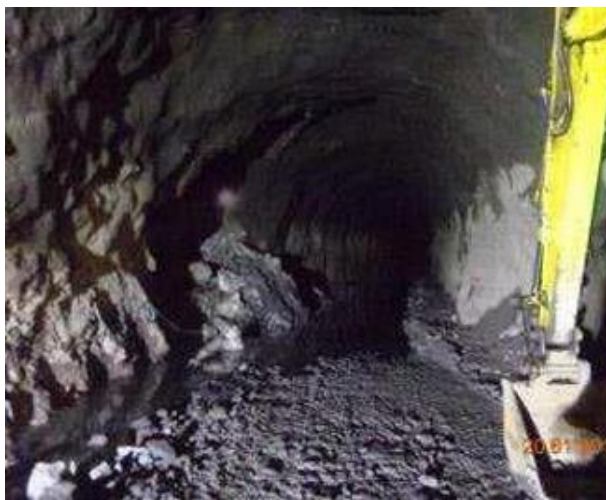
### Damaged Tunnel sections

- While several blockages and collapses were identified, the total length of all damaged areas **did not extend 300 m**. The damage was noticed in Skhalta-Didachara Transfer Tunnel and Shuakhevi Headrace Tunnel. No damages were observed in Chirukhistsqali -Skhalta Transfer Tunnel.
- Cracks in shotcrete and problems with rock bolts indicated deficiencies in some of the installed support systems.

- Areas with fault zones and weak rock formations, such as "red breccia," were closely associated with the collapses. Such fault zones and weak rock formations were primary contributors to the failure of some of the tunnel sections.
- As mentioned above, more than 1,000 rock samples were sent to foreign internationally recognised laboratories. The testing revealed that some rock types exhibited significant reductions in strength and durability under wet conditions, contributing to structural instability. As a result, when exposed to water certain rock samples swelled and deteriorated. This water effect on certain rocks turned out to be another contributor to the issues with some of the tunnel sections.
- At some locations, the issues of fault zones, weak rock formations and water impact on some rocks were unforeseen and thus could not be fully addressed at the design stage.
